Weekly Construction Report

Hatchery Creek Design/Build Project

Time Period:	August 24-29, 2015	Project No:	1305
Rain Days/Weather Conditions:	No rain this week.		
Personnel on-site:	<p><i>EcoGro/Ridgewater:</i> Tom Cutter, Eric Dawalt, Jim Hanssen, Larry Mounce, Brad Redmon, Randall Starns, Sherri Arthur Trucking-John Arthur.</p> <p><i>Stantec:</i> George Athanasakes and Michael Sendelbach for survey stakeout and wood loading measurements on Monday and Tuesday.</p>		
Equipment on-site:	Komatsu PC 360 excavator w/ hyd. thumb, Komatsu PC 450 excavator, Komatsu PC 220 long arm excavator, Komatsu PC 160 (mobilized Monday) and Terex TA27 articulated off-road dump truck.		
Material deliveries to project site:	<ul style="list-style-type: none"> ▪ One pallet of wooden stakes for erosion control blanket ▪ 883 tons of 24"+ diameter rock to Site #3. ▪ 24 tons of #2 stone installed on haul roads. 		
Work performed the past week:	<ul style="list-style-type: none"> • Site #3/Step Pool Reach ~Sta. 159+25 to 160+50: <ul style="list-style-type: none"> ○ Excavated soil that had washed into channel down to design excavation grade. ○ Built floodplain berm at head of step pools with excavated soil. ○

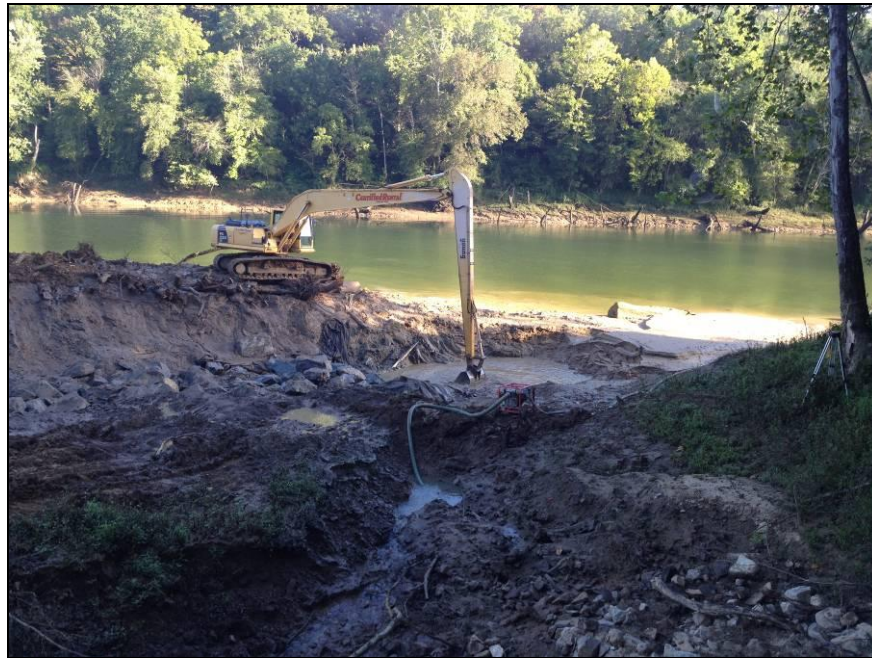
Excavating washed in soil with long arm excavator on Site #3 at ~Sta. 159+75 during no flow release from Wolf Creek Dam. (Picture taken looking downstream towards Cumberland River).

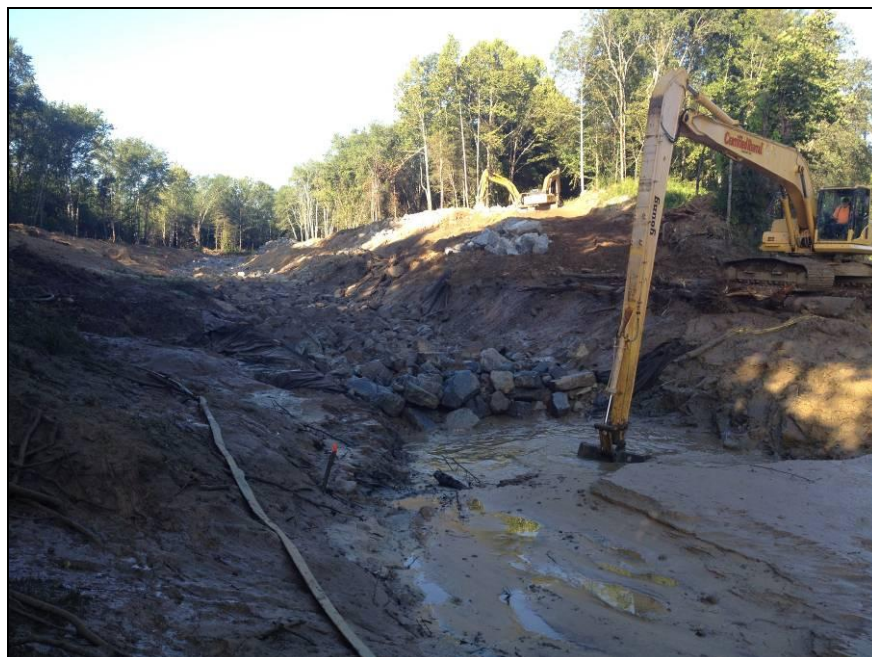
Excavating washed in soil with long arm excavator on Site #3 at ~Sta. 159+75 during no flow release from Wolf Creek Dam. (Picture taken looking upstream from Cumberland River).

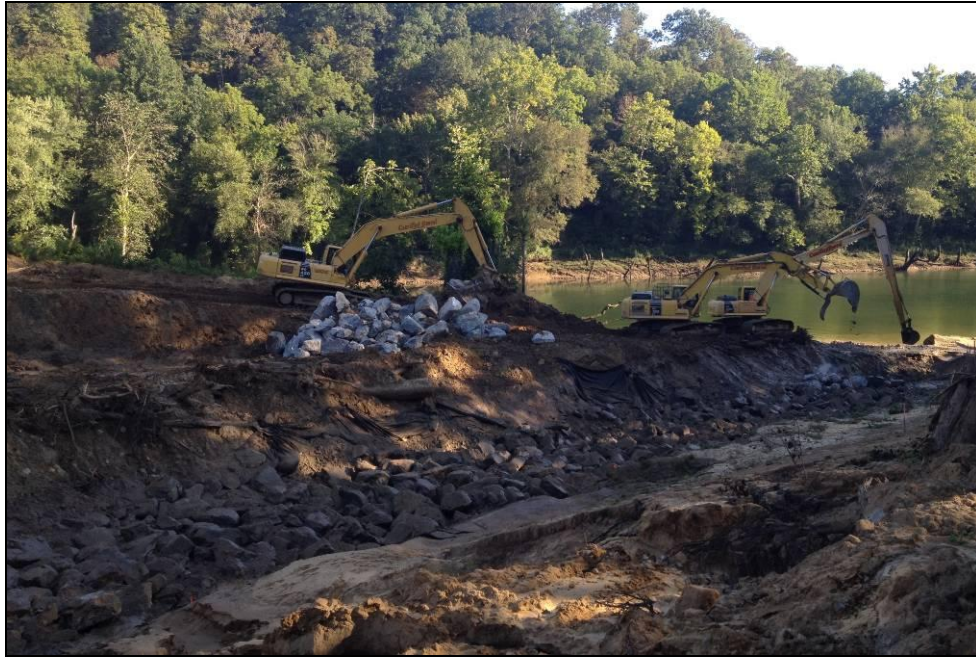
Installing 24" diameter rock in channel at ~Sta. 159+75. (Picture taken looking downstream towards Cumberland River).

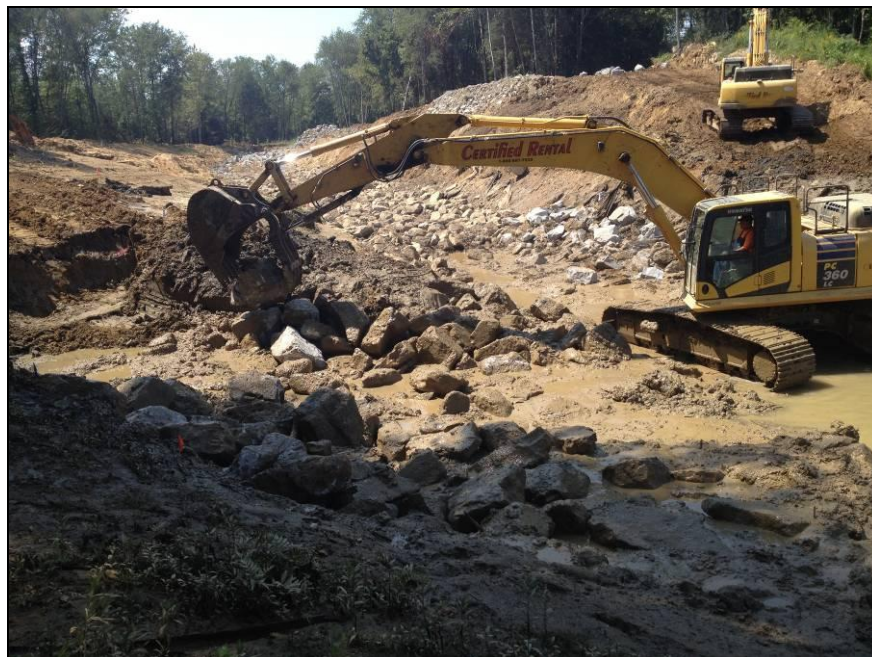
Installing 24" diameter rock in Tributary Z channel at ~Sta. 159+70. (Picture taken looking upstream from Cumberland River).

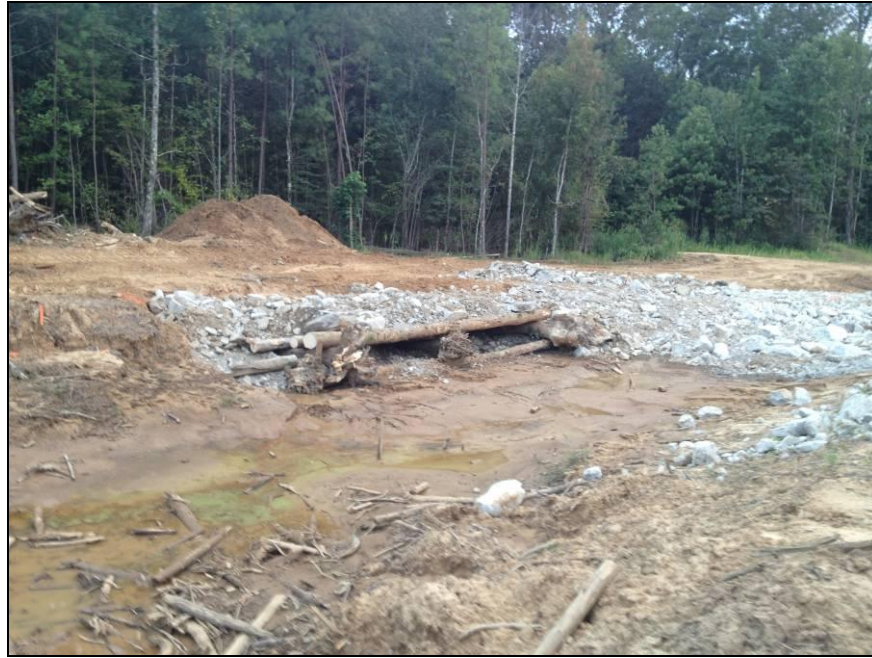
"Lunker bunker" rock/wood toe installed in pool at Sta. 145+25. (Picture taken from ~Sta. 145+50 looking upstream at right descending bank).
